# Debris/Ice/TPS Assessment And Integrated Photographic Analysis For Shuttle Mission STS-53

DEBRIS/ICE/TPS ASSESSMENT  
AND  
PHOTOGRAPHIC ANALYSIS  
OF  
SHUTTLE MISSION STS-53

December 2, 1992

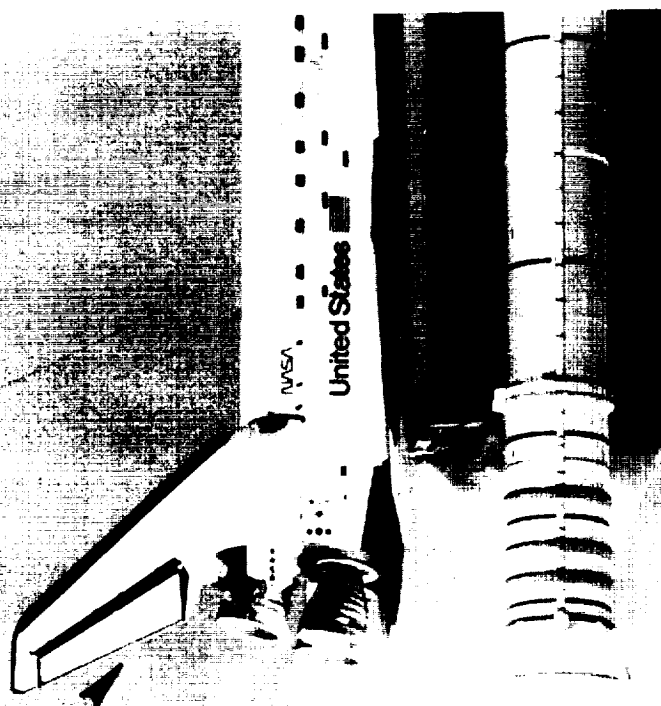
Water vapor/condensate trailed from the split rudder  
speed brake drain hole after liftoff

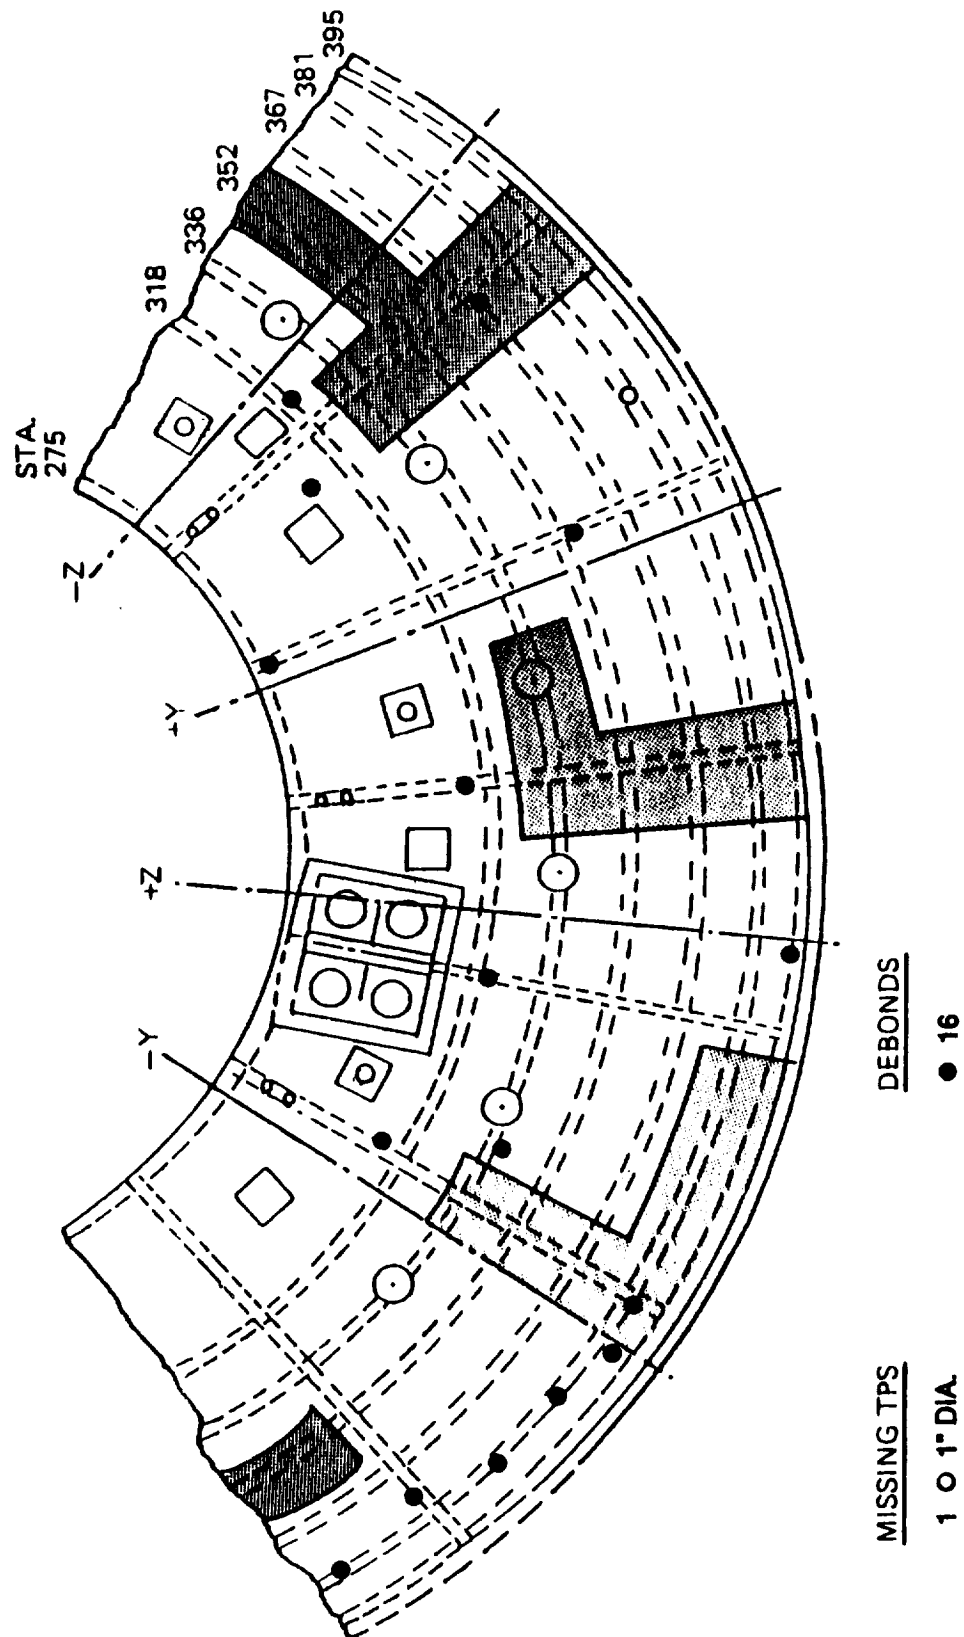
Figure 4. RIGHT SRB FRUSTUM

The RH frustum had 16 MSA-2 debonds and one 1-inch diameter area of missing TPS between the +Y and -Z axes at the 381 ring frame (Figure 4). Minor localized blistering of the Hypalon paint had occurred along the 395 ring. All BSM aero heatshield covers were locked in the fully opened position.

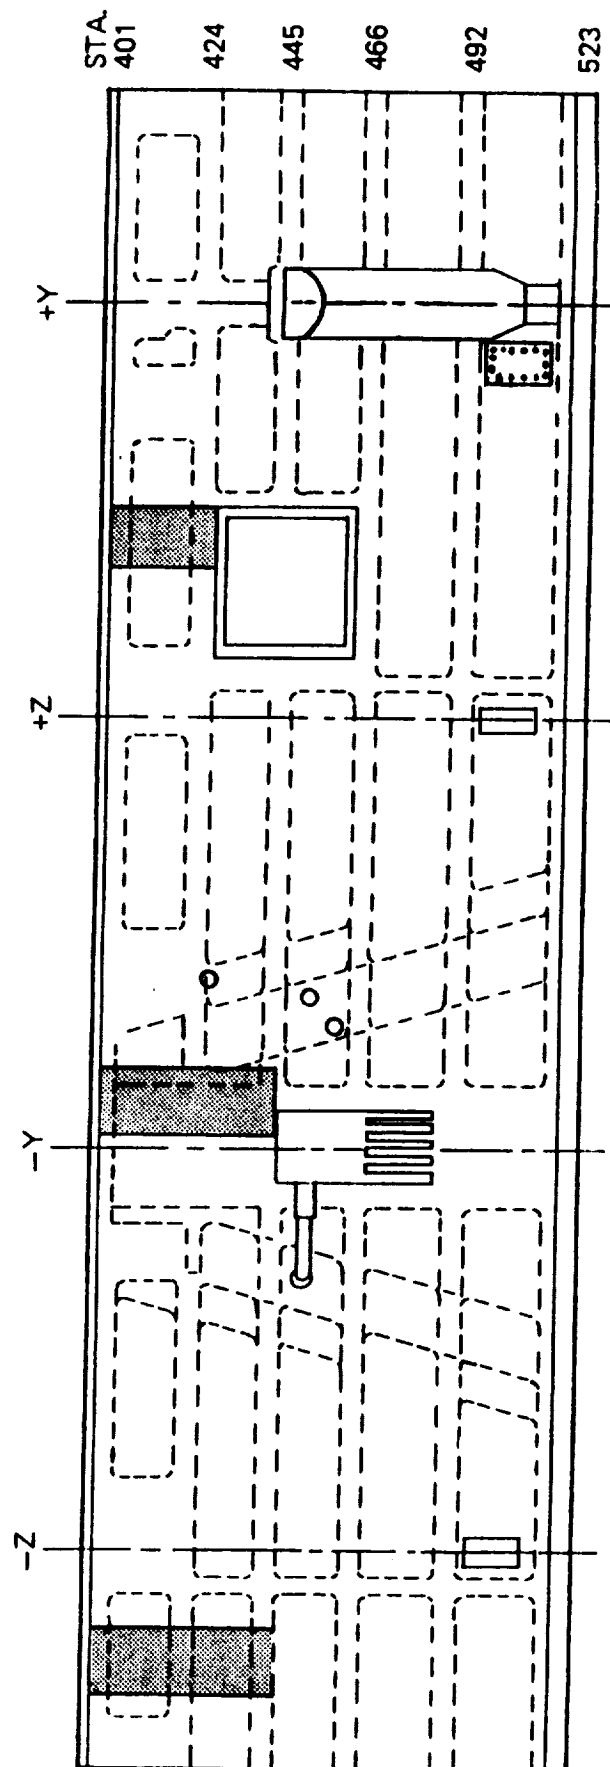
Figure 5. **RIGHT SRB FWD SKIRT**

The RH forward skirt exhibited no debonds or missing TPS. Both RSS antennae covers/phenolic base plates were intact. Minor blistering of the Hypalon paint occurred on the systems tunnel cover and around the ET/SRB attach point (Figure 5). No pins were missing from the frustum severance ring. The forward separation bolt and electrical cables appeared to have separated cleanly.

MINOR BLISTERING OF  
HYPALON PAINT ON SYSTEMS  
TUNNEL COVER AND AROUND  
ET/SRB ATTACH POINT

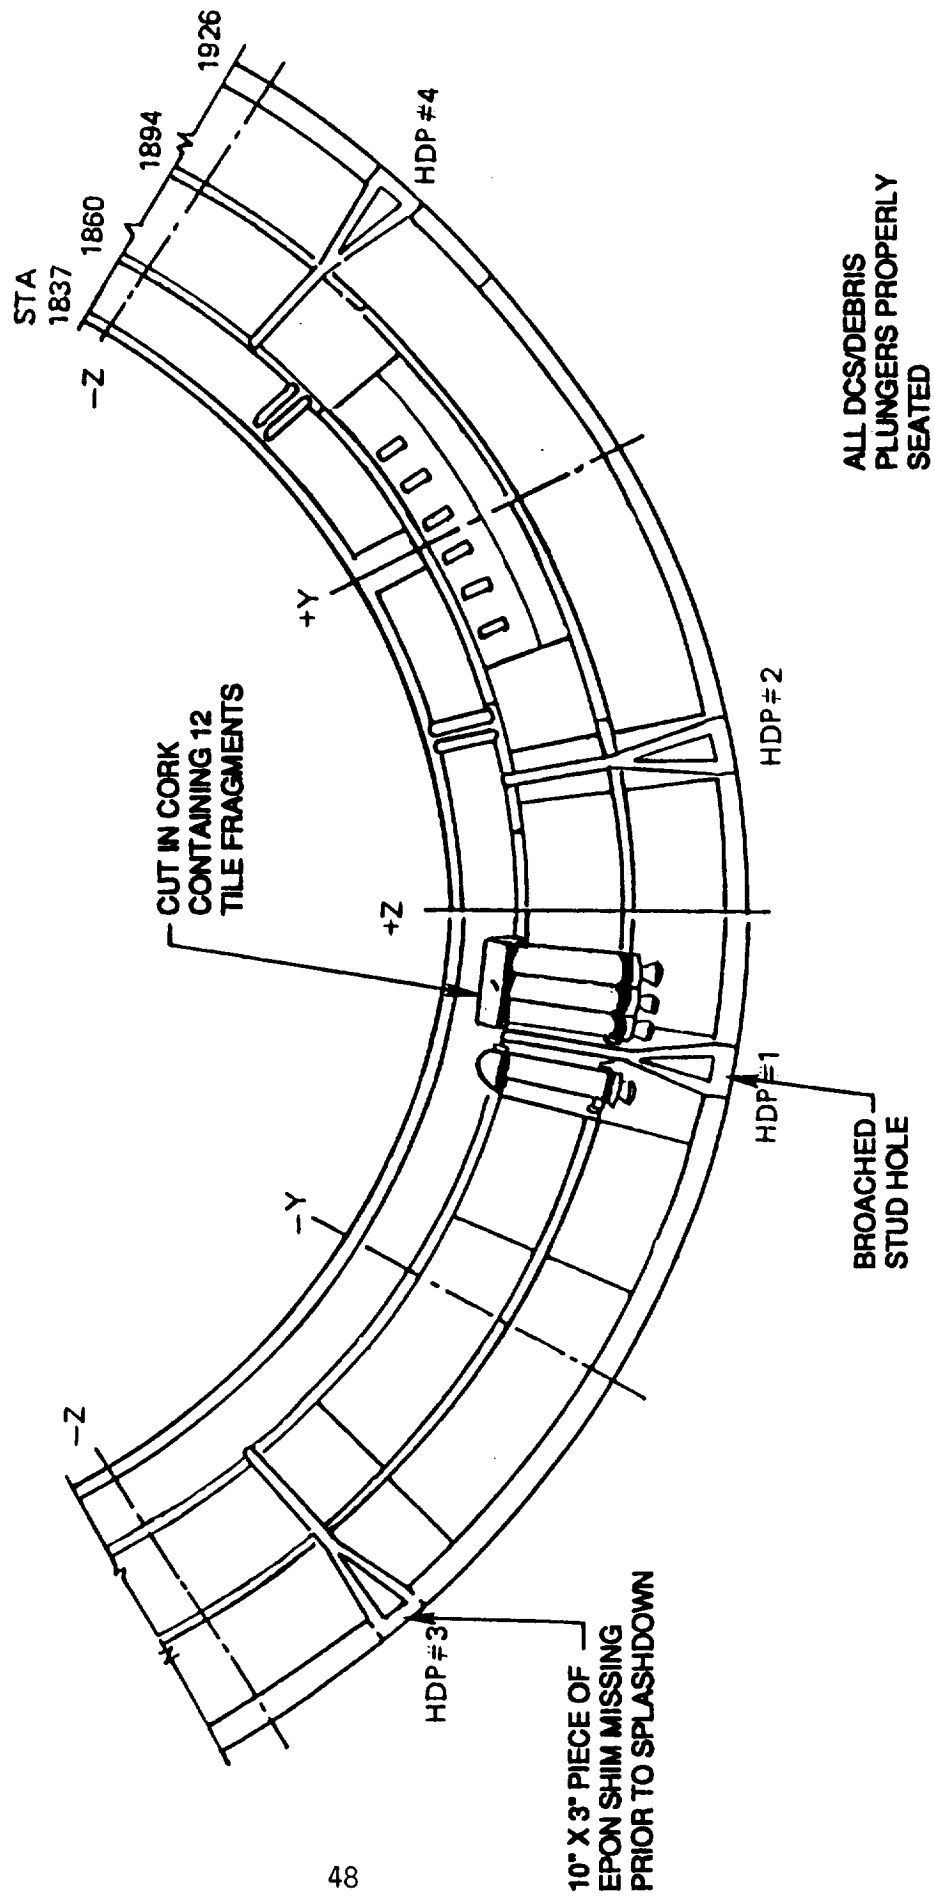
Figure 6. RIGHT SRB AFT SKIRT EXTERIOR TPS

The HDP #1 stud hole was broached due to a stud hang-up. A 10"x3" area of EPON shim was missing from HDP #3 (Figure 6). The material was lost prior to water impact (sooted/charred substrate). All Debris Containment System (DCS) plungers were seated properly.

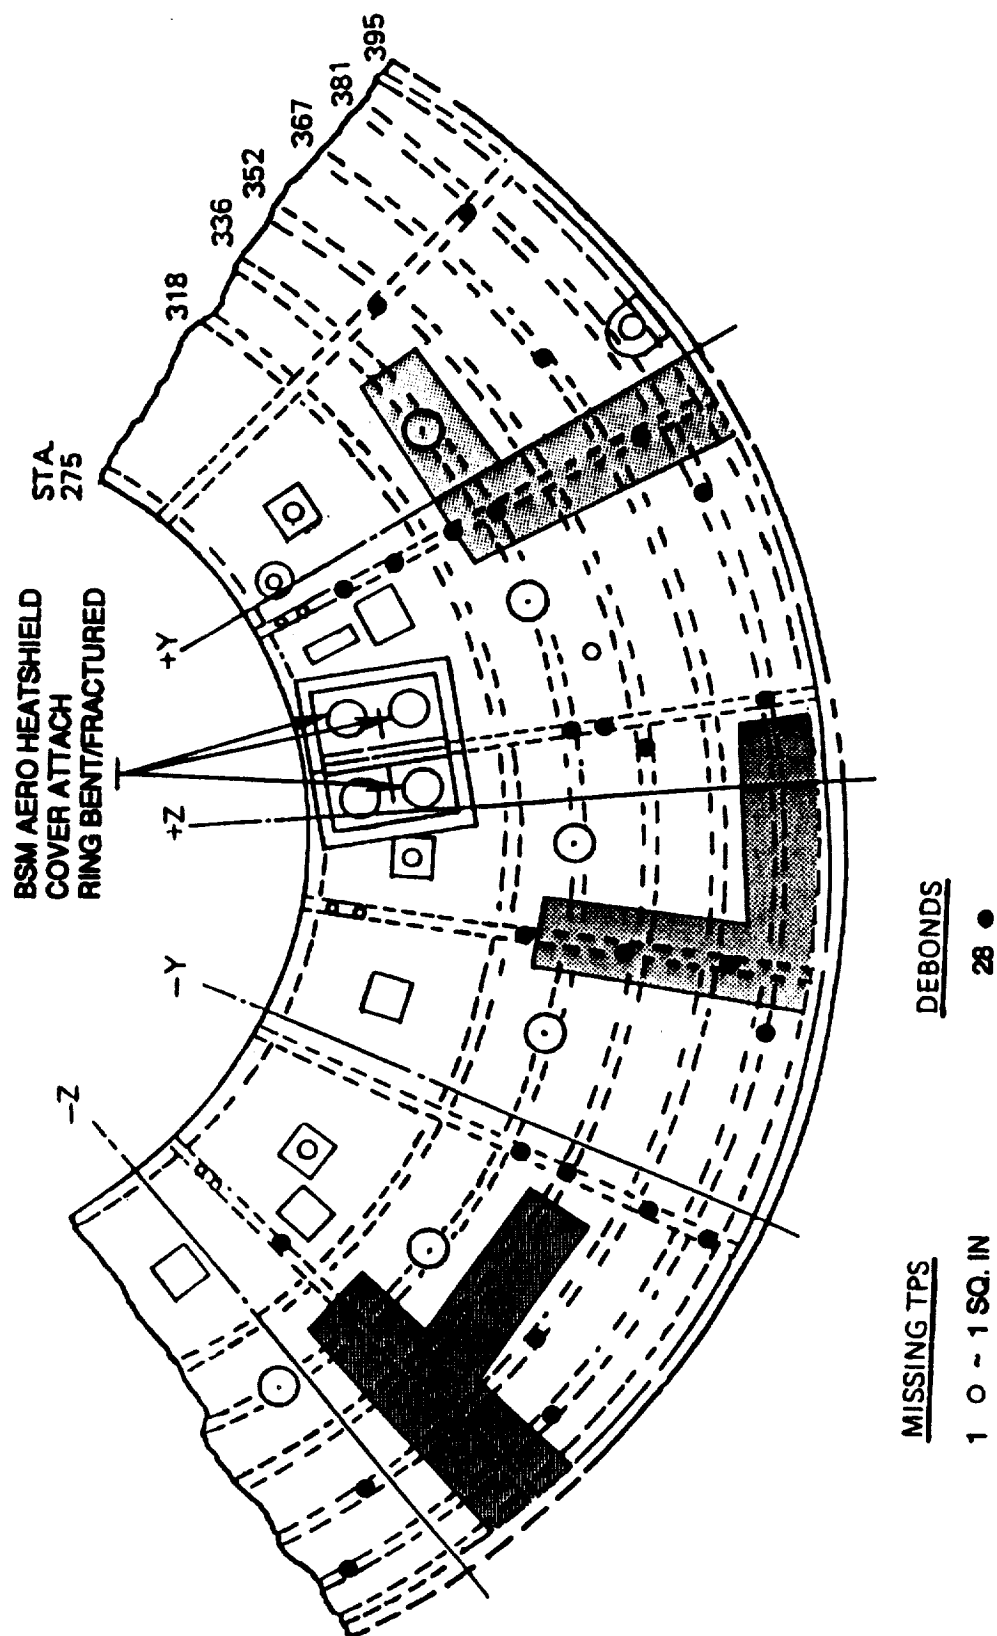
Figure 7. LEFT SRB FRUSTUM

The LH frustum had 28 MSA-2 debonds over fasteners. Torn and missing MSA-2 (1-inch diameter) from one location between the +Y and +Z axes just aft of the 336 ring frame may have been the result of handling damage (Figure 7). There was minor localized blistering of the Hypalon paint. The BSM aero heat shield covers were locked in the fully opened position, though three of the four cover attach rings had been bent by parachute riser entanglement.

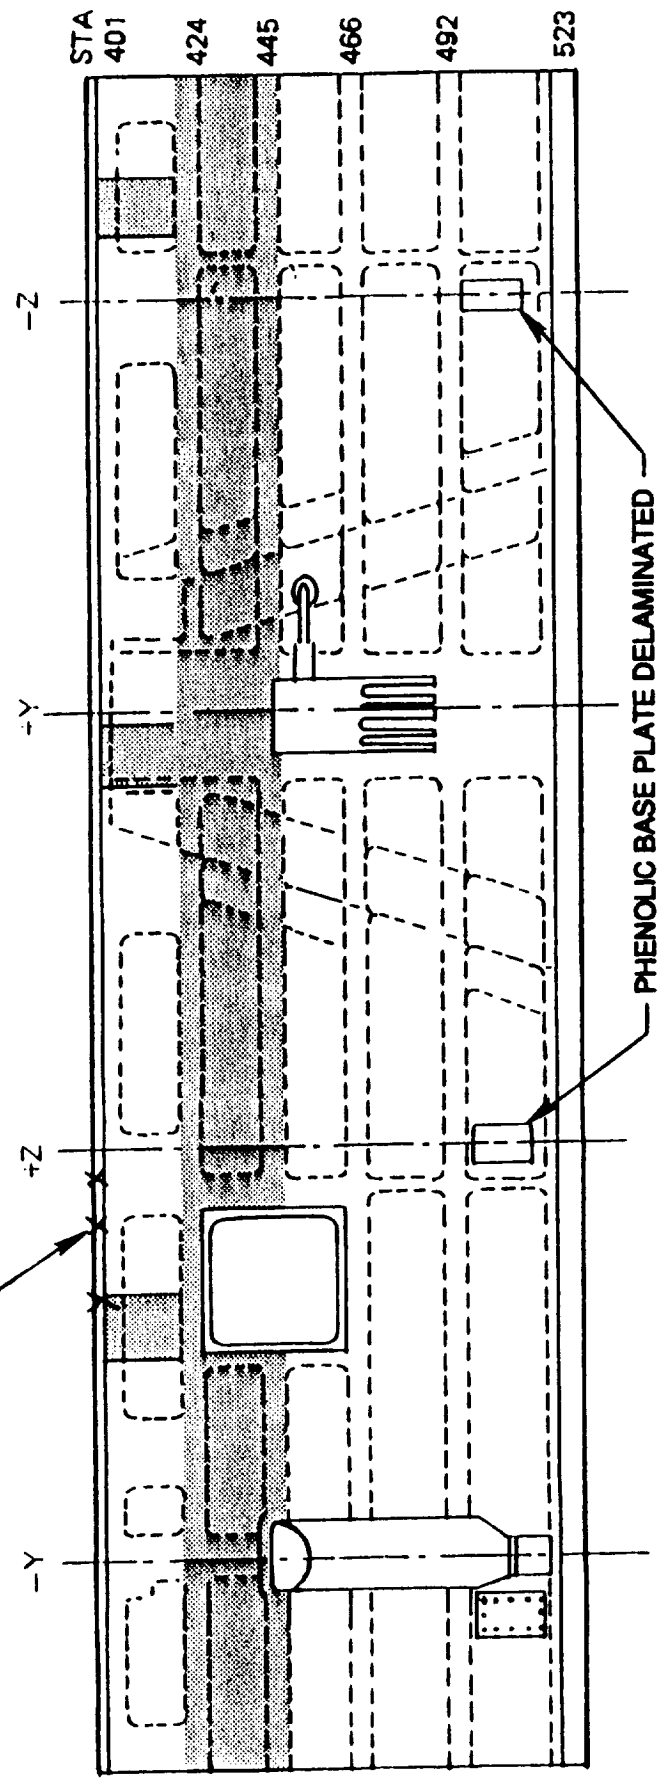
Figure 8.

The LH forward skirt exhibited no debonds or missing TPS. The phenolic plates on both RSS antennae were intact, but delaminated. The forward separation bolt and electrical cables appeared to have separated cleanly. Three pins were missing from the frustum severance ring, a condition that reportedly was the result of parachute entanglement (Figure 8). Minor blistering of the Hypalon paint occurred near the ET/SRB attach point and on the systems tunnel cover.

3 FRUSTUM SEVERANCE  
RING PINS MISSING

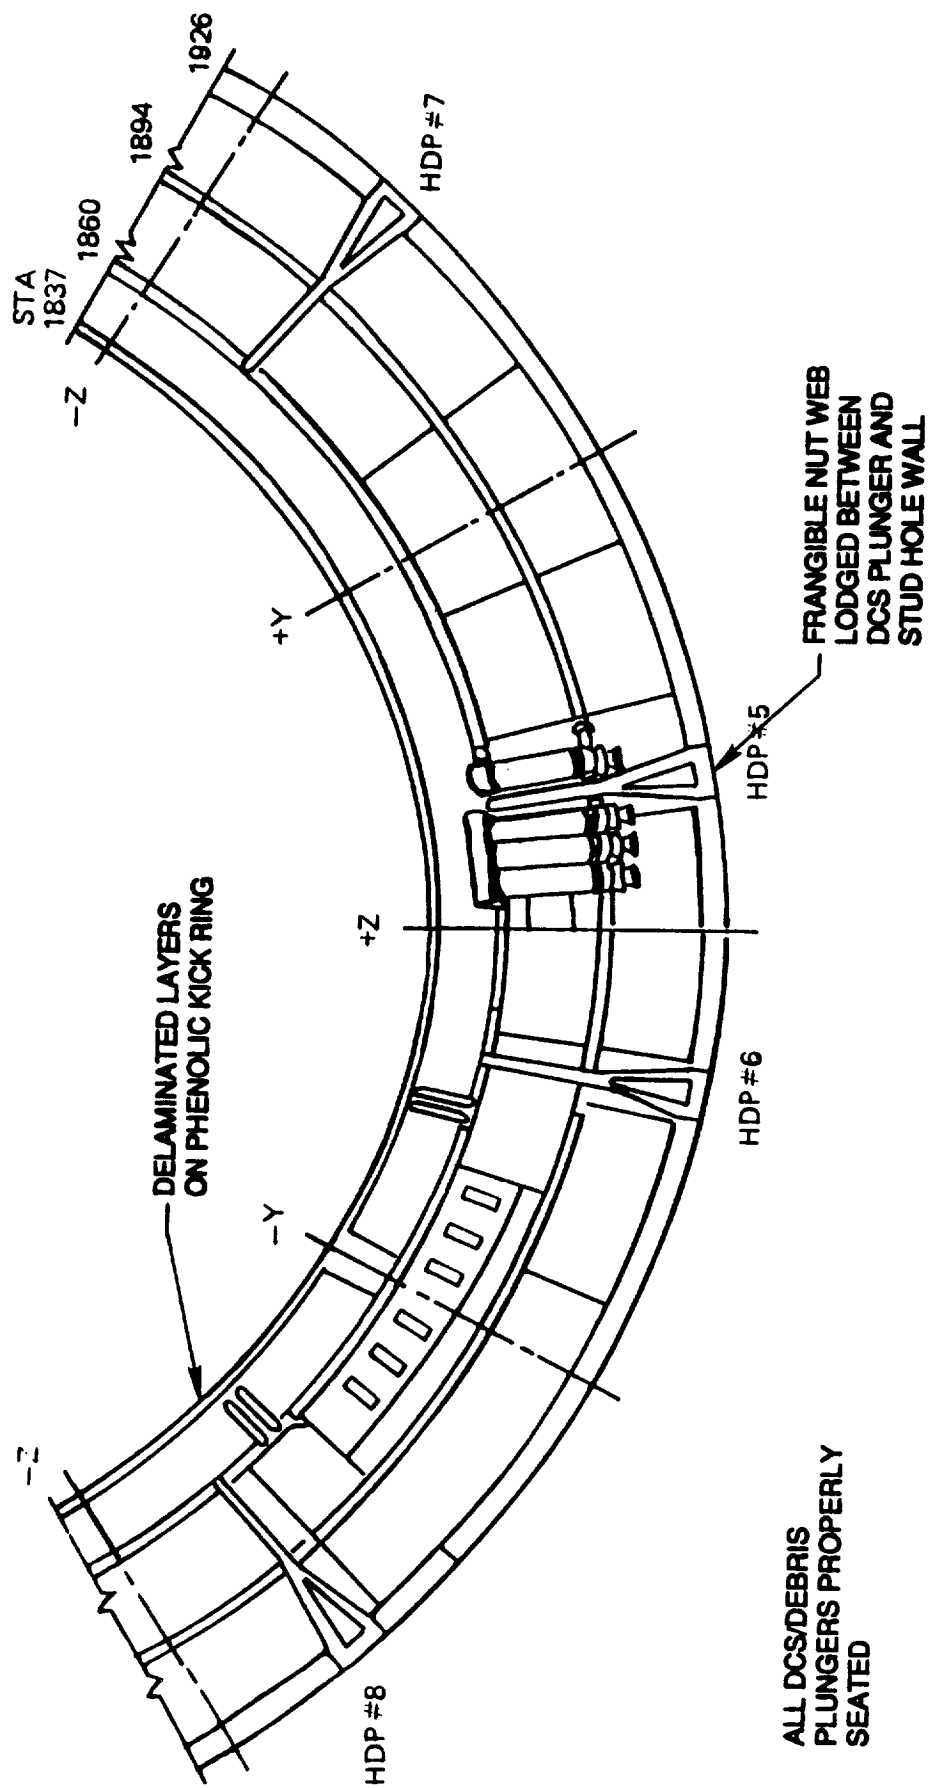
Figure 9. LEFT SRB AFT SKIRT EXTERIOR TPS

All four Debris Containment System (DCS) plungers were properly seated, though a frangible nut web was caught between the DCS debris plunger and the stud hole wall. The small K5NA repair on the inside of the HDP #5 foot, which was applied 24 hours prior to launch, was intact. None of the EPON shim material was lost prior to water impact (Figure 9).

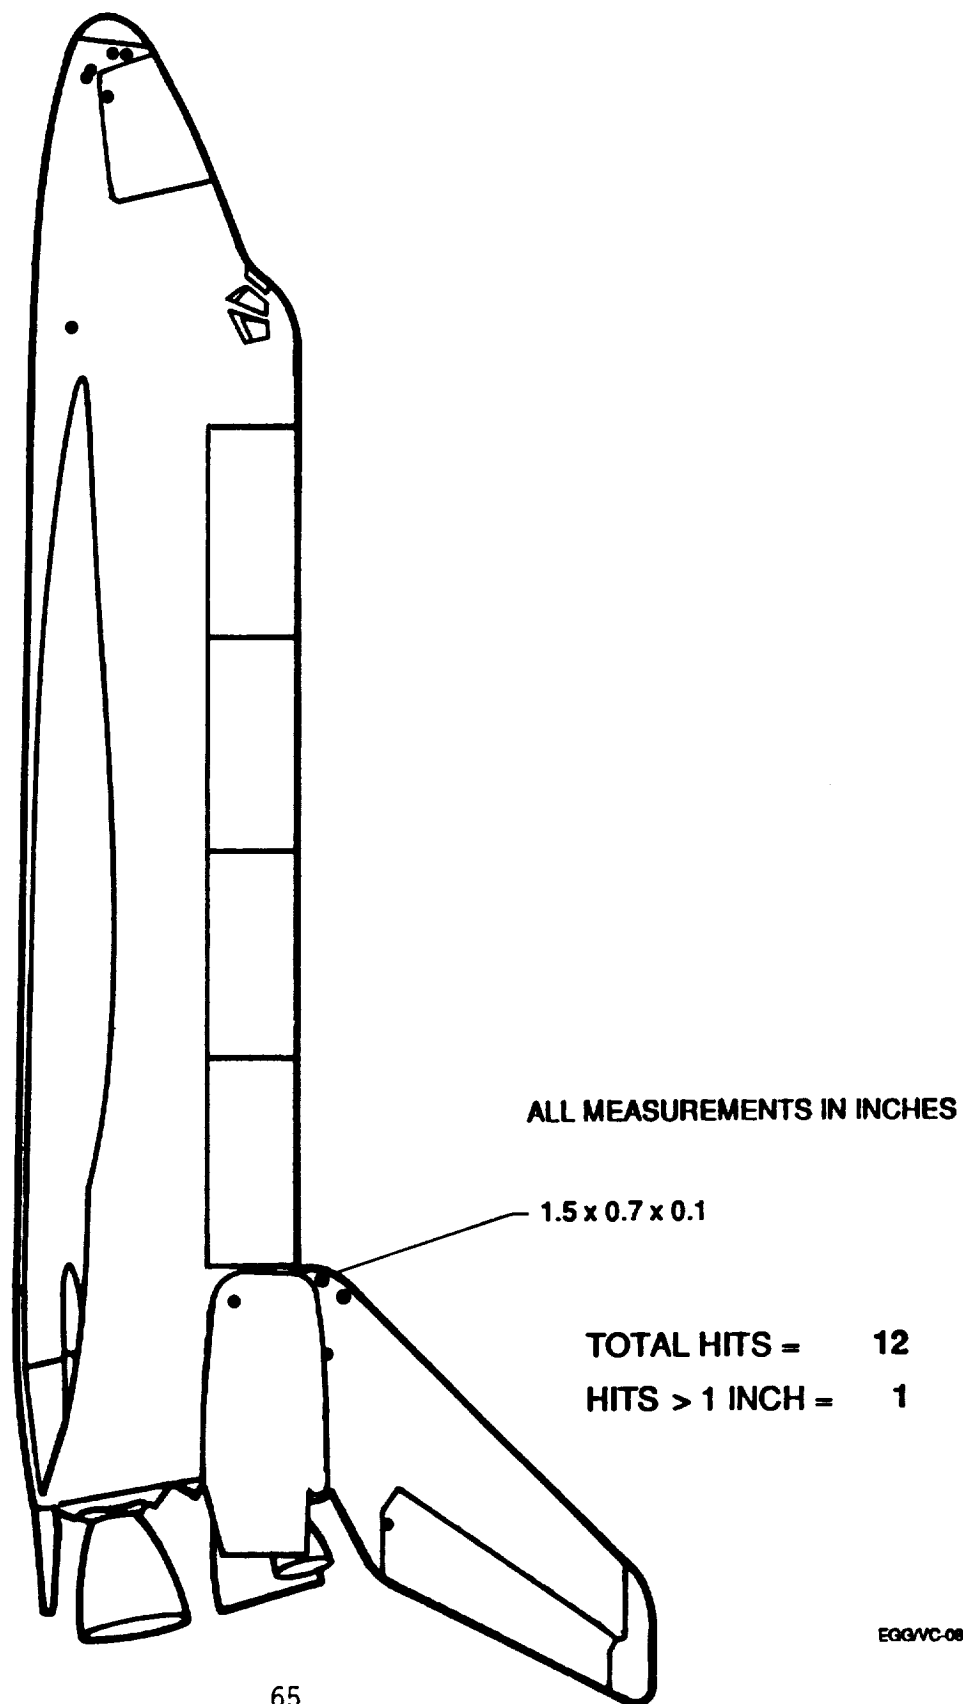
Figure 11. **DEBRIS DAMAGE LOCATIONS**

The tiles on the left OMS pod leading edge sustained more damage than usual. Access to this area was not available at Dryden, therefore the number of impact sites and dimensions shown in Figure 11 are approximate. The cause of this damage is still undetermined.

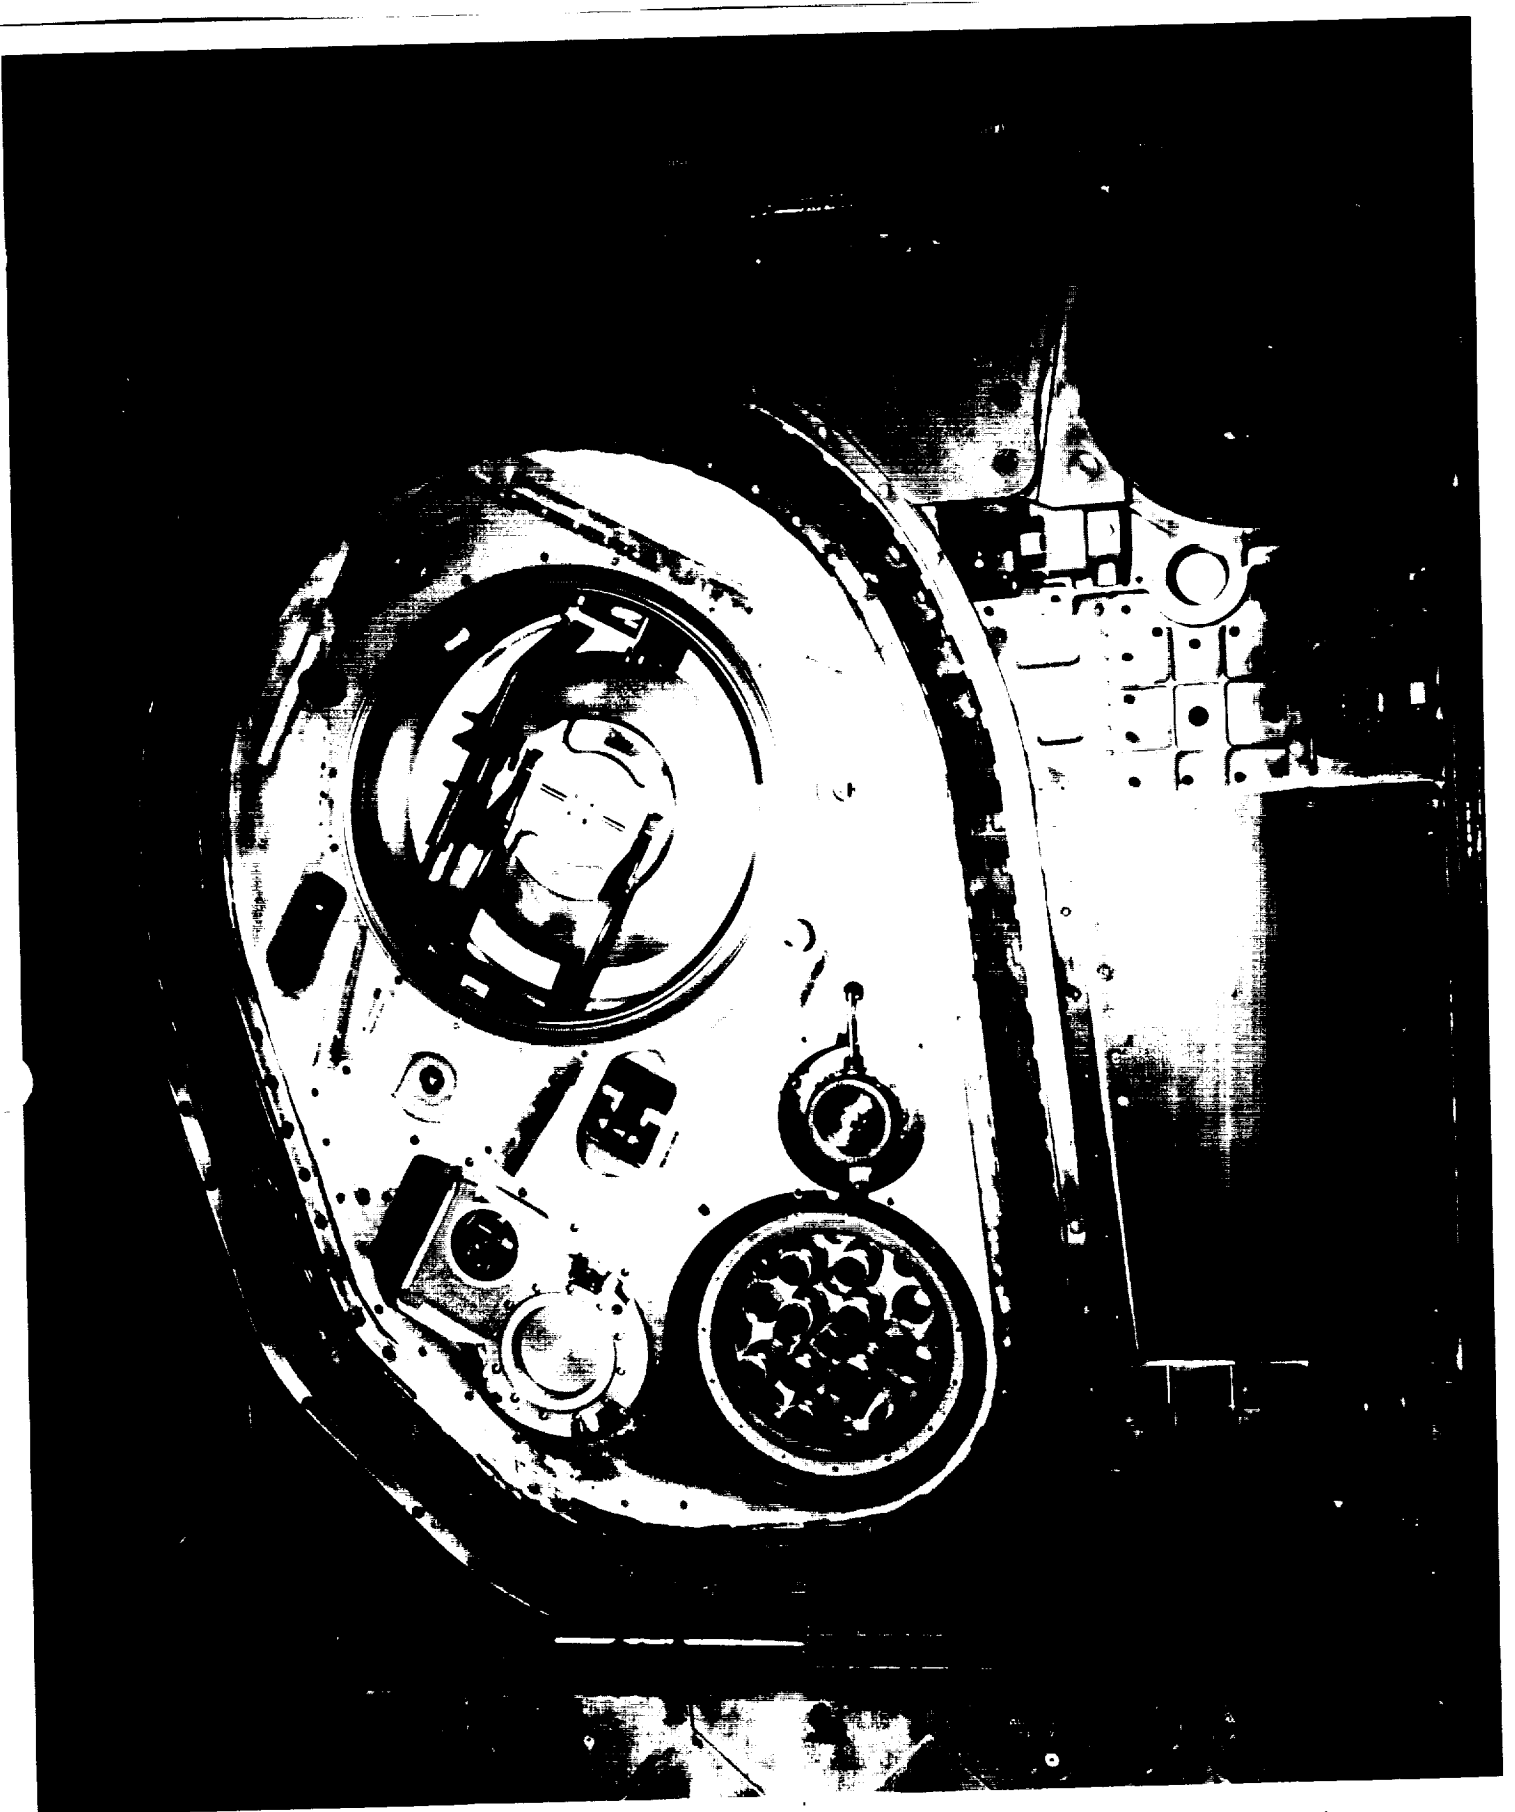
Overall view of the LH2 ET/ORB umbilical. All separation ordnance devices functioned properly. No flight hardware was found on the runway below the umbilical when the ET door was opened.

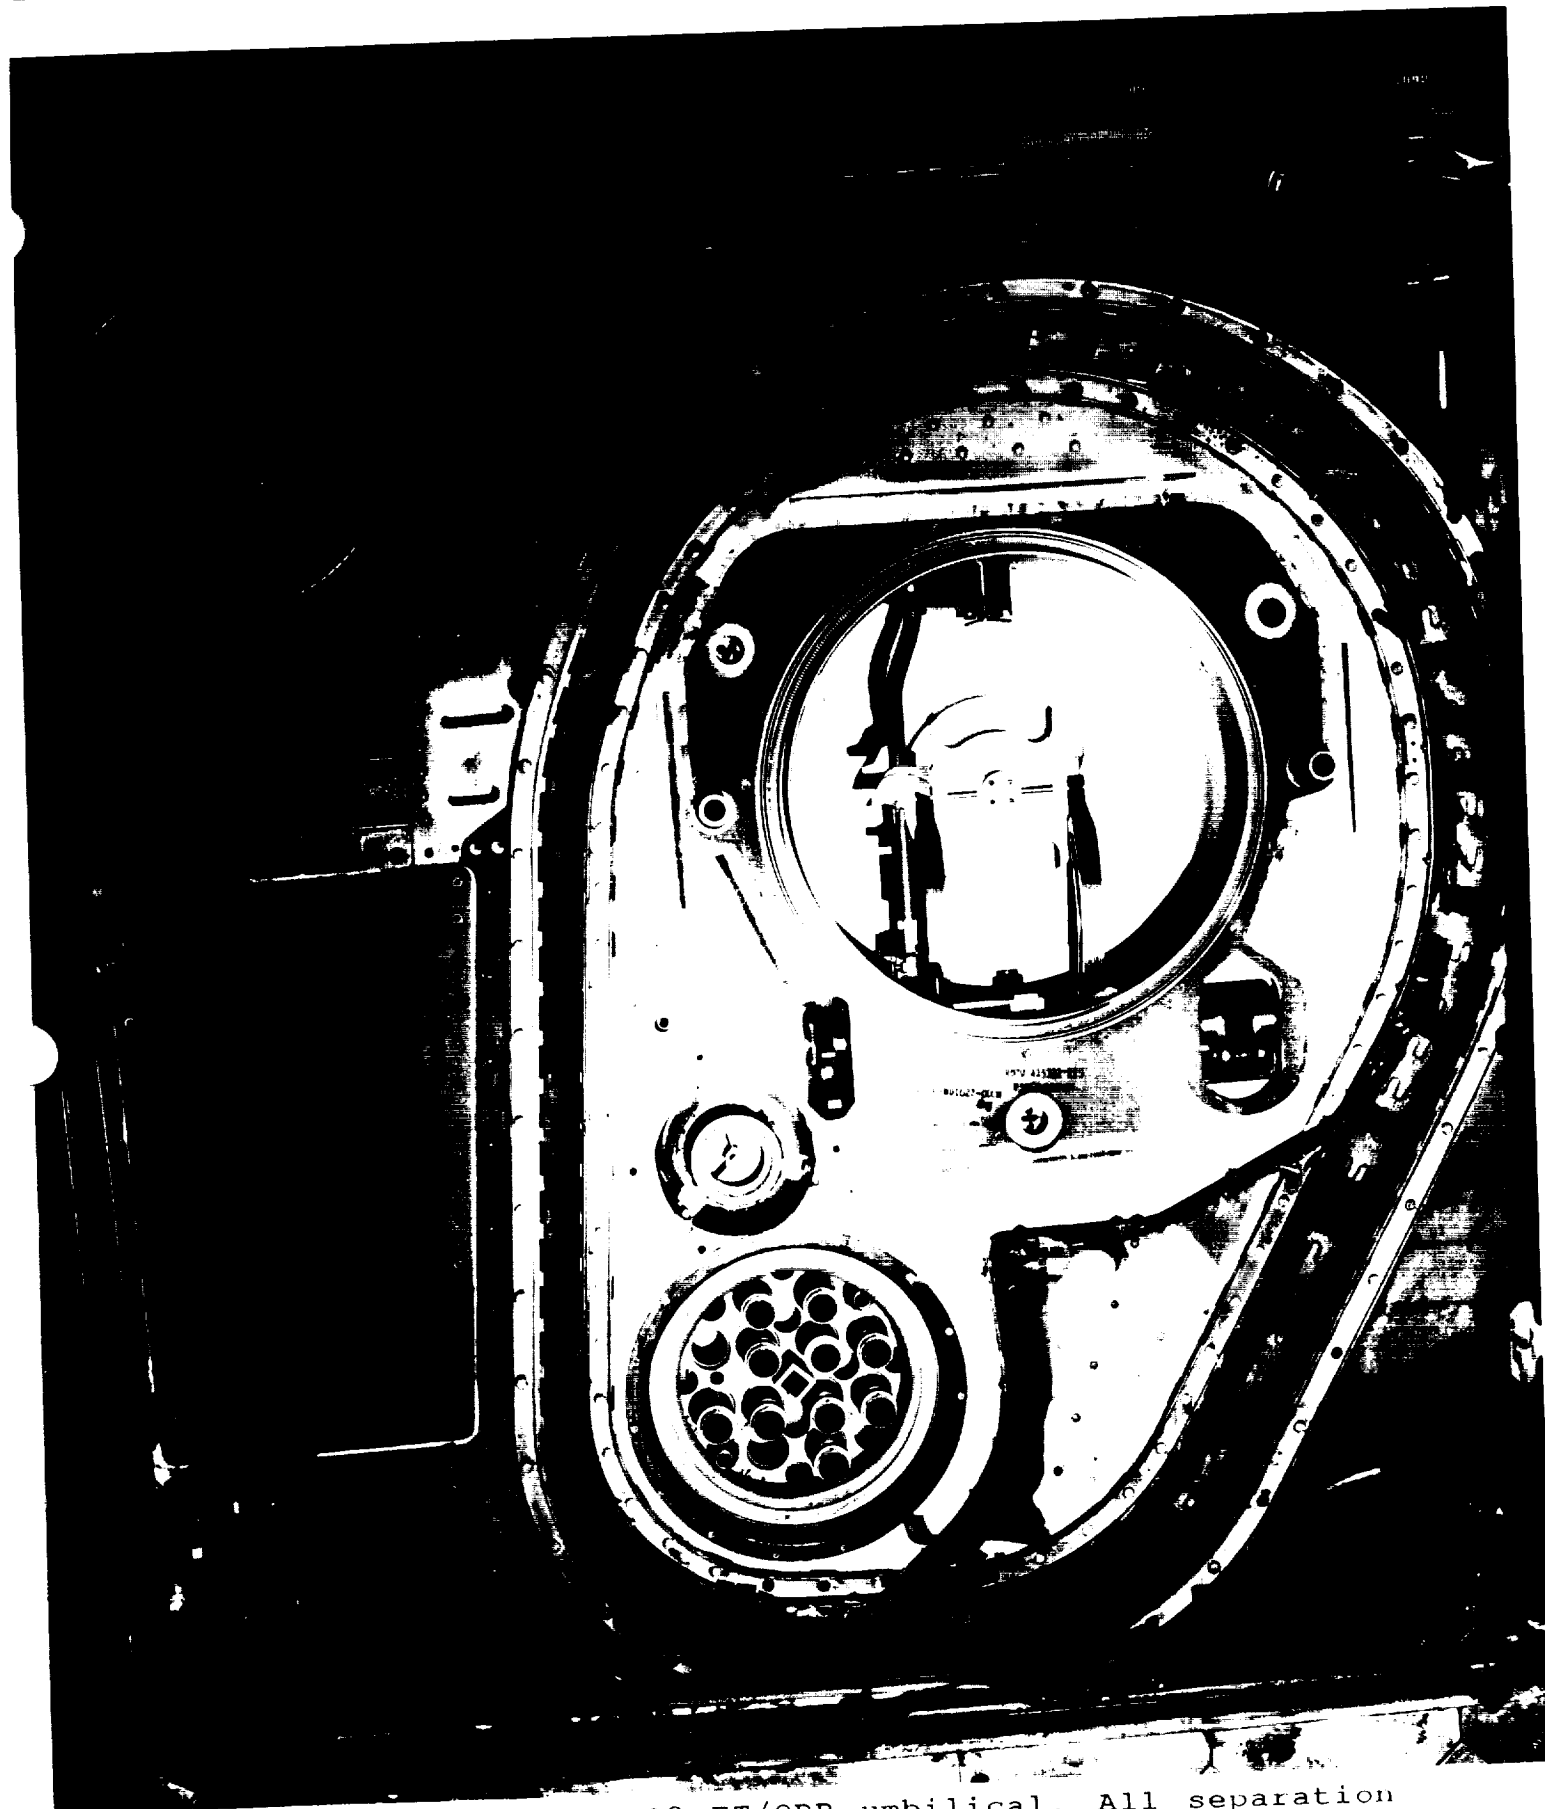
Overall view of the LO2 ET/ORB umbilical. All separation ordnance devices functioned properly. No flight hardware was found on the runway below the umbilical when the ET door was opened.

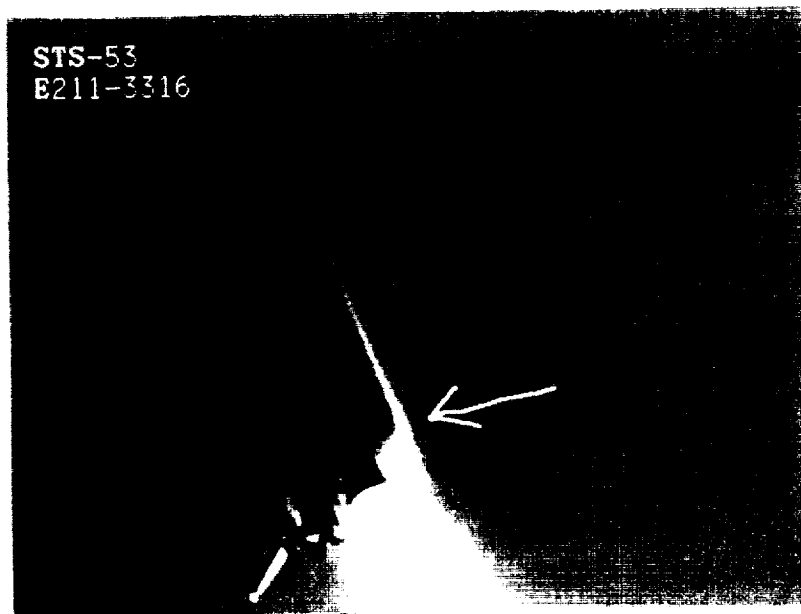
**Figure 2.3.3 Vapor from -Z side of ET after Liftoff**

Vapor was noted to drift from the bottom (-Z side) of the ET after the roll maneuver. The source of the vapor is probably the frost noted on the north side of the ET prior to liftoff. No further photographic analysis has been requested.

Figure 2.3.3 shows the vapor originating from the -Z side (north side of the ET at liftoff) of the ET. The source of the vapor is probably the frost observed from this area prior to liftoff. This vapor is not considered an anomaly.

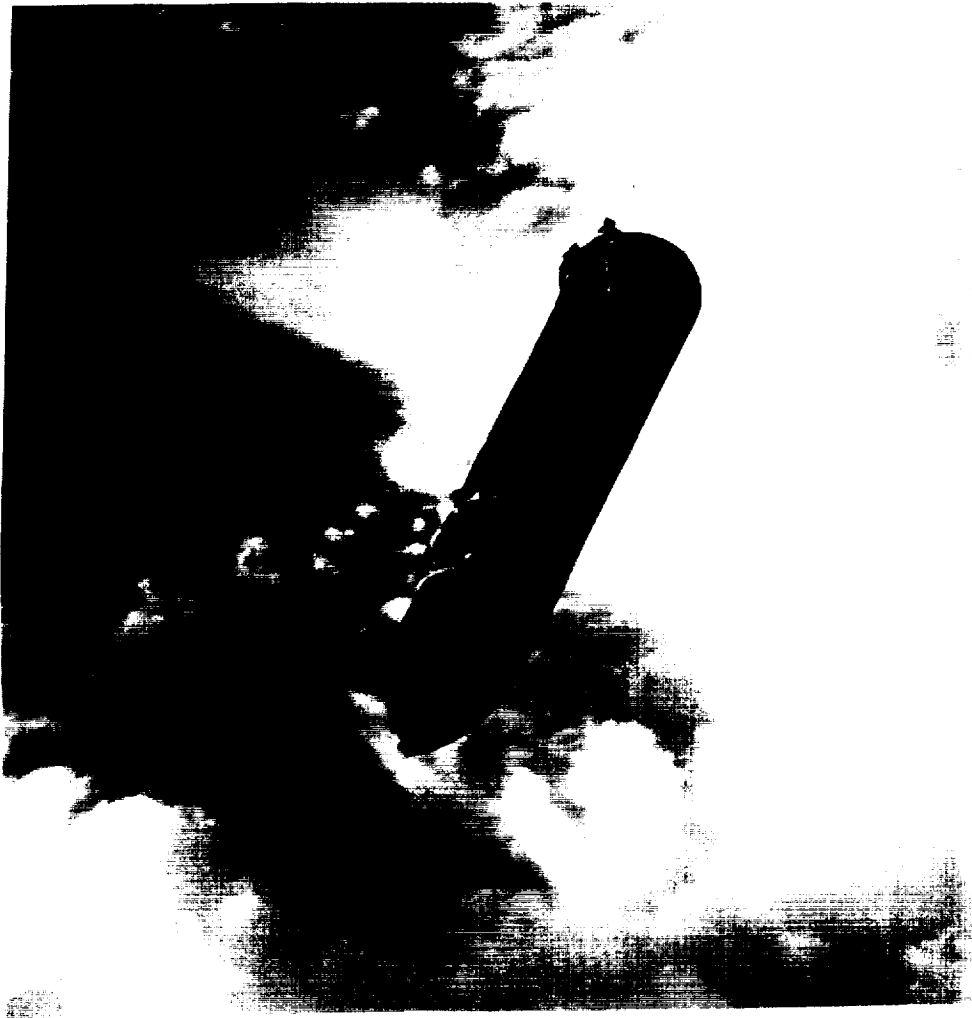
**Figure 2.4b View of ET with 300 mm Focal Length Lens with a 2x Extender**

Figure 2.4b shows the ET with an effective 600 mm focal length lens. This photograph was taken approximately five minutes after the photograph in Figure 2.4a. This is the first time the long focal length lens has been used in conjunction with DTO-0312.
